PRINCE WILLIAM  
Soil and Water  
Conservation  
DISTRICT

Notes from the field  
By Kate Norris  
Prince William Soil & Water Conservation District

December 2009

**Spring/Summer 2009**

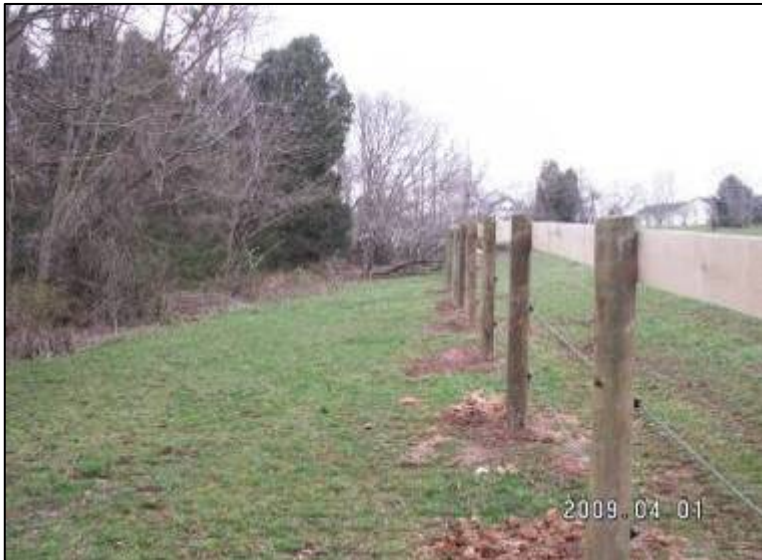
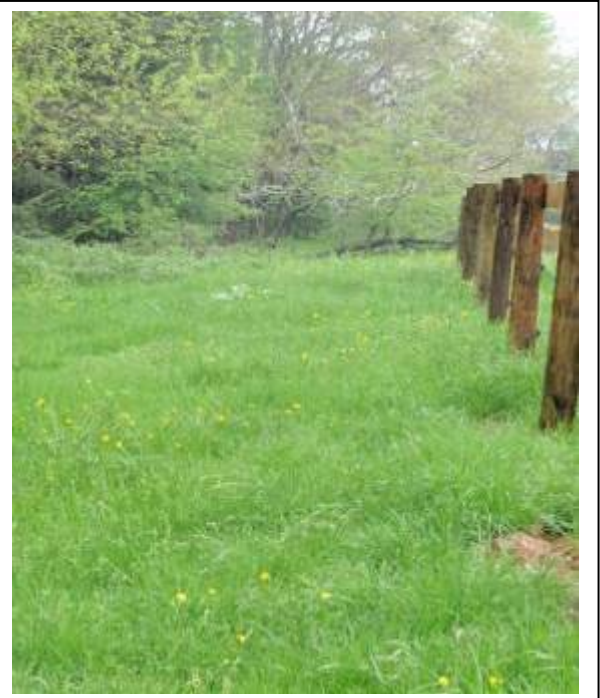
Above, streamside buffer just after fencing the horses away. To the right, the buffer after 5 weeks of rest and growth.

The spring of 2009 was WET! The rainfall was fantastic for the renovation of our southern pasture and streamside buffer.

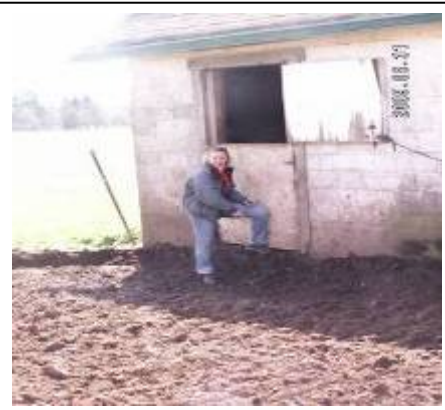
We removed more than a foot of organic muck and replaced it with bluestone gravel dust.

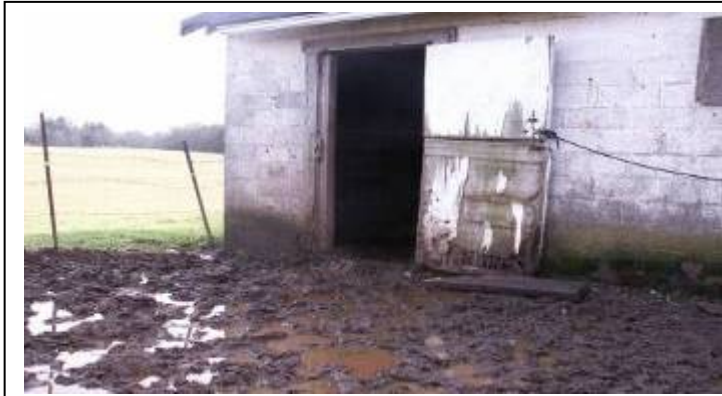
In the photo you'll see the "before" conditions. Notice there is a lip in front of the stall that is preventing some of the muddy water from getting into the barn. When we removed the muck and replaced it with bluestone we made the paddock level with the stall opening – thinking that it would be easier to get the wheelbarrow over the threshold. Well, that was true, but the level surface was also allowing rainwater to enter the stall more easily.

"Before" the bluestone paddock was installed water pooled in front of the stall.

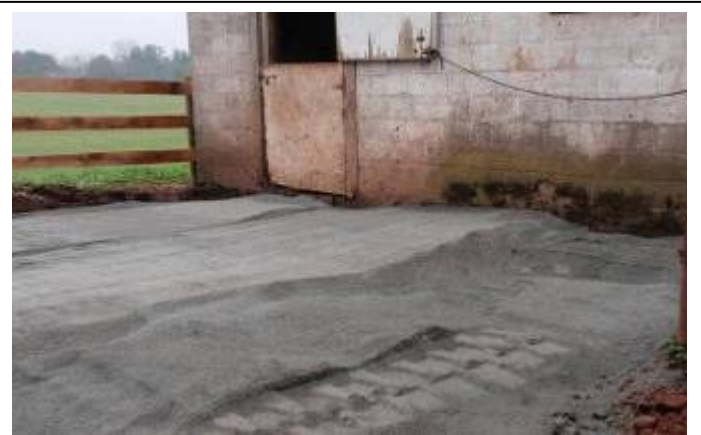
Bluestone dust was placed on top of the filter fabric, level with the door to the stall.

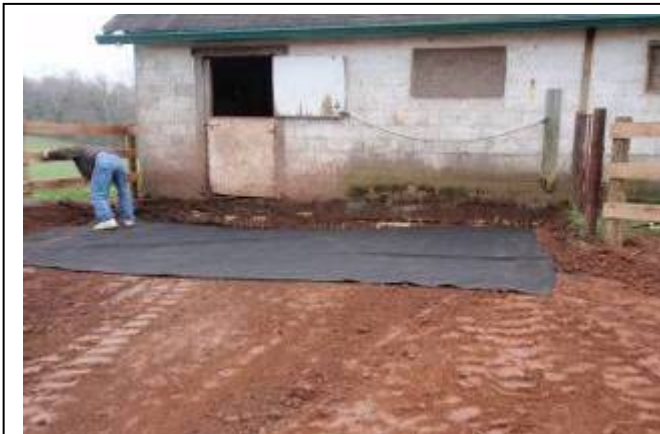
We used a felt-like material called filter fabric in front of the barn that will allow rainwater to soak through but will keep the soil from rising up and mixing with the bluestone.

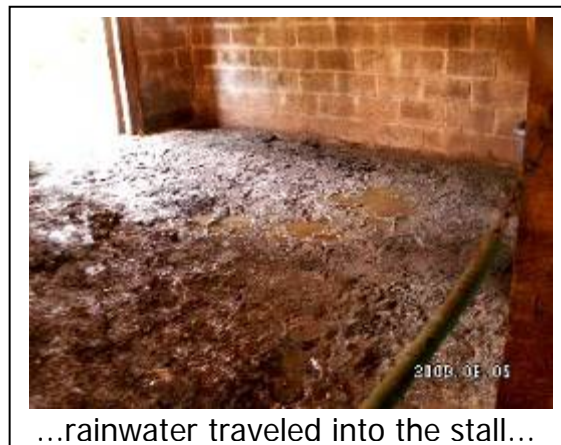
But it caused some problems in our northern sacrifice area paddock. The rainwater was washing across the paddock and in heavy storms running into one of the stalls. It wasn't happening every time it rained but with so many very heavy rainstorms it was happening often enough to cause concern for us and frustration for Edith Kennedy the owner of Oakwood. Water runs downhill. Even though we had eliminated the mud through the installation of our bluestone paddocks we had not graded the paddocks well enough to direct the stormwater flow.

...rainwater traveled into the stall...

Instead we opted to try a simple solution of creating a couple of drainage swales across the paddock. The swales would direct the rainwater to the adjacent hayfield and reduce the volume and velocity of the rainwater moving toward the barn and stall door.

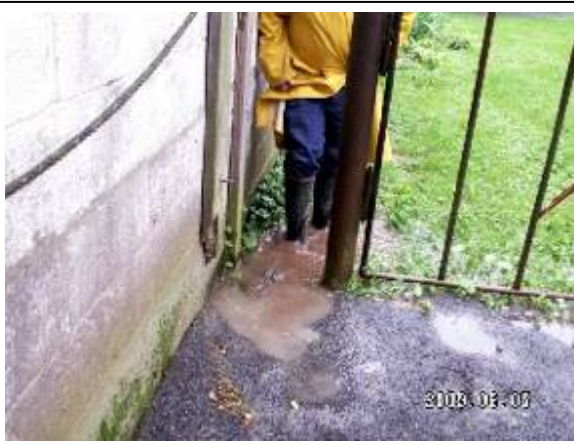
...and pooled in front of the barn.

When the spring rains arrived, water pooled in a low spot in front of the barn or traveled into the stall.

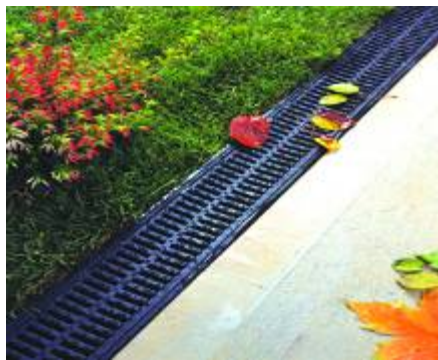
This was one type of drain we considered installing

We worked with Barry Lubar, Construction Coordinator, with one of our partners [Angler Environmental](#) to develop a solution. We discussed installing a drain grate but decided it could be a hazard to the horses in icy weather conditions or if the horses had shoes on. We also knew it would require regular maintenance to remove gravel that would wash in.

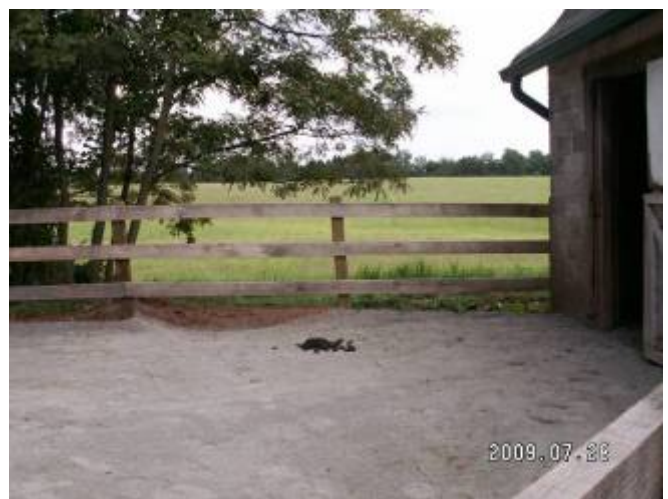
This is one of two swales installed to re-direct the rainwater.

Three months later this solution is working fairly well except in very heavy storms. We will probably make the swale a little deeper during the next construction phase of the project.

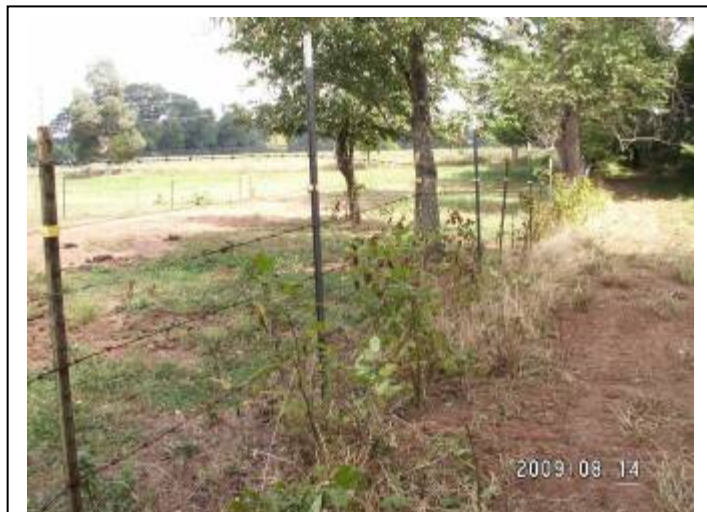
Old barbed-wire fencing left the farm looking Less than horse-friendly

Thanks to this partnership we were able to remove the old barbed-wire fencing and replace it with [Kencove's](#) HorseCote and HotCote high-tensile fencing. We installed 5-strands of wire, electrifying the top and third strands with solar chargers. The farm now demonstrates 5 different types of fencing that horse farms may consider using on their properties.

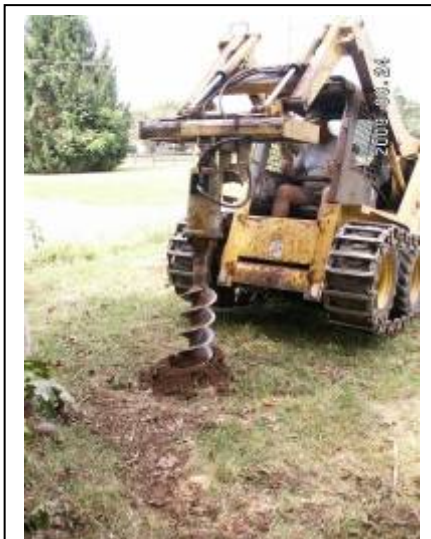
We dug the posts where necessary

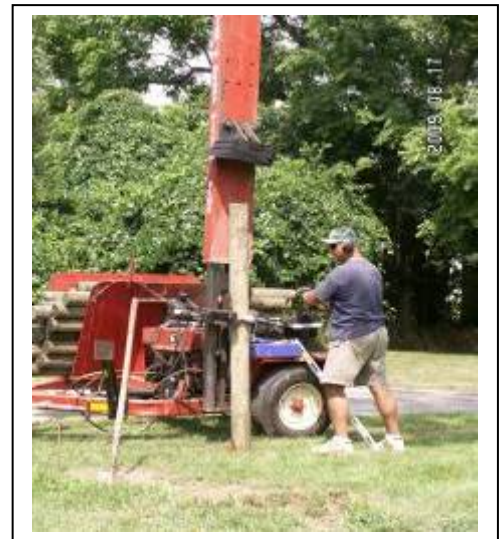
We drove the posts where possible

hoped to be able to drive the posts into the ground than dig post holes and use concrete. The soil didn't always cooperate with us so the final product mixture of both. "Driven posts" are hammered into ground with a driver and are supposed to result in

a more stable post which is especially important in any type of tension fence like ours.

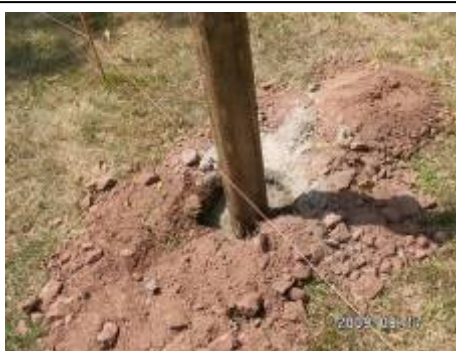
Where necessary the post holes were dug and concrete was used to add stability

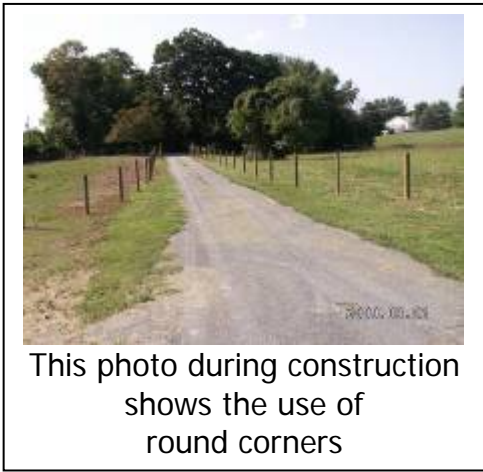
This photo during construction shows the use of round corners

The lines of the fence are generally curved instead of having right-angle corners which require extra labor and posts. Curved fence lines are believed to be safer for horses. The curved fence lines look great.

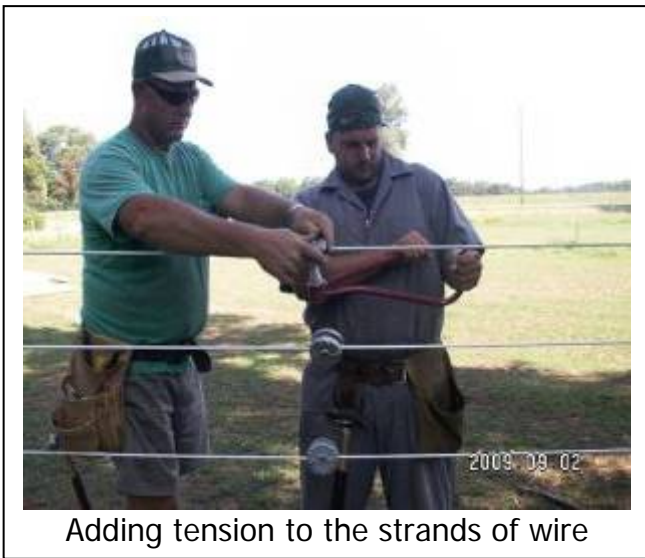
Adding tension to the strands of wire

Once the posts were secure, the insulators installed, the wire strung, and the bracing braced it was finally time to add tension to the fence.

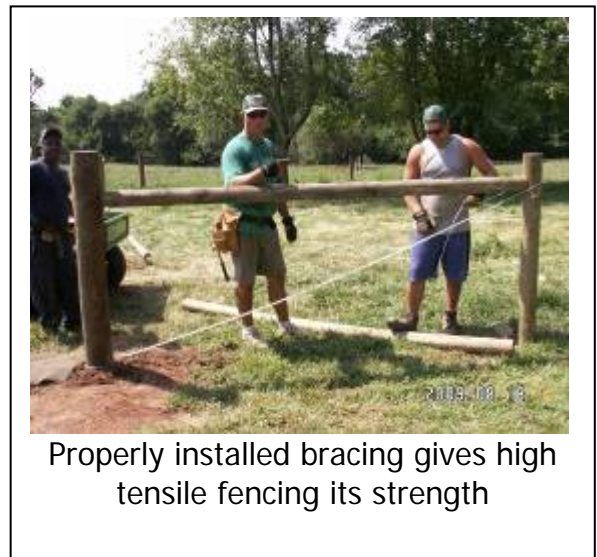
Properly installed bracing gives high tensile fencing its strength

Curtis taught us about high tensile fencing throughout the process. Periodically we were quizzed on which direction the bracing should be pulling. I had to visualize a giant hot air balloon in the sky pulling the fence with the cross bracing wire as the tail end of the rope attached to that balloon. Looking at the photo below, that hot air balloon would be pulling the fence from the sky to the right of Curtis and crew.

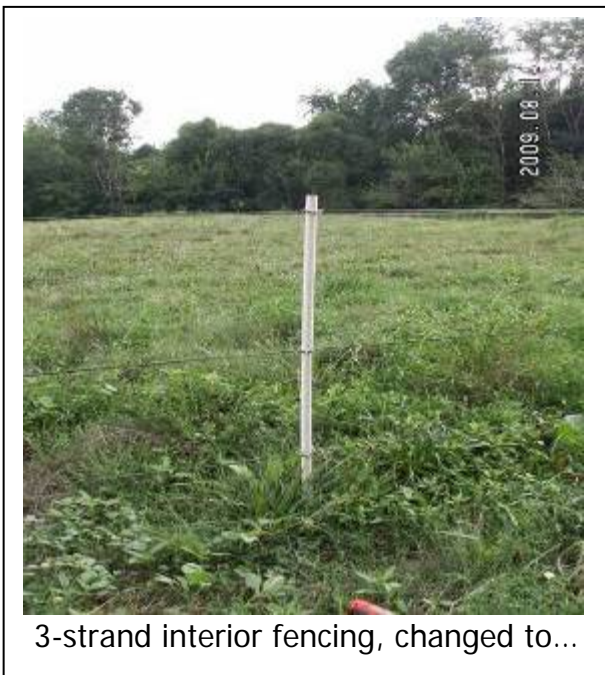
3-strand interior fencing, changed to...

installed practices for any maintenance issues. We decided to remove one strand of electrified rope from an interior fence line. A low strand of electrified fencing can easily become grounded by tall grasses or weeds and cause your electric fence to fail. As you can see from the photos we really didn't need the lower strand to confine the horses.

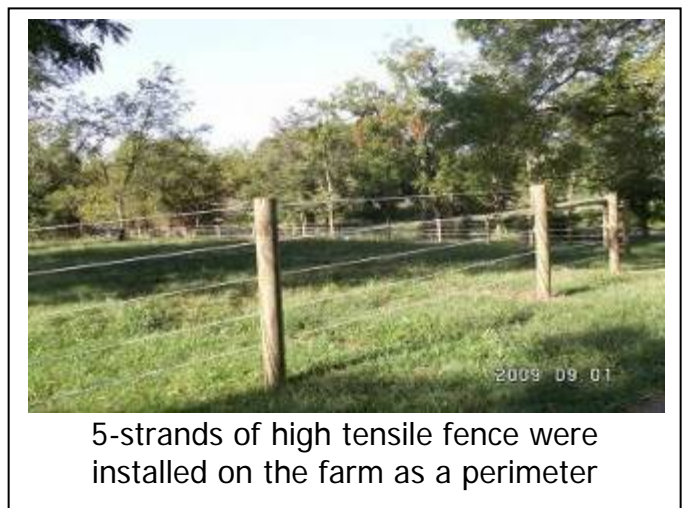
5-strands of high tensile fence were installed on the farm as a perimeter

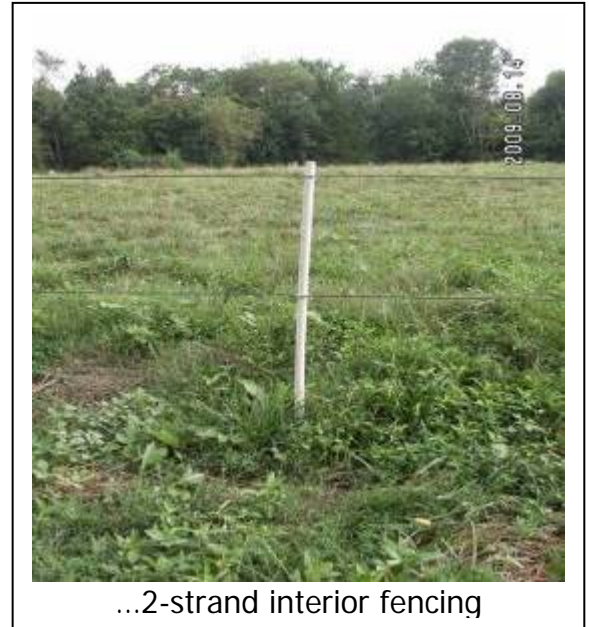
...2-strand interior fencing
